CASE STUDY: Mackay Cyclone, 1918

By Mr Jeff Callaghan

Retired Senior Severe Weather Forecaster, Bureau of Meteorology, Brisbane

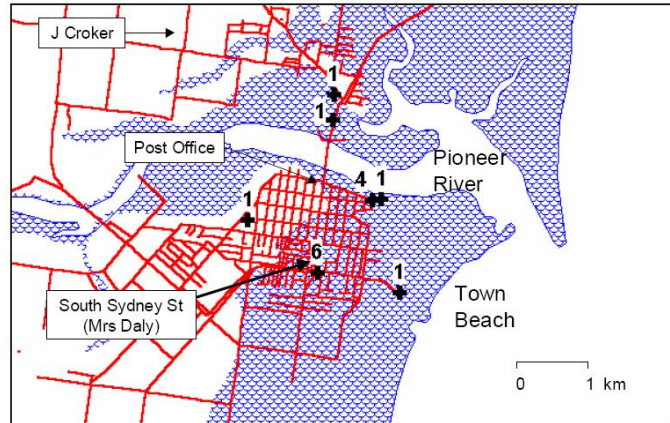
Map of the inundation in Mackay 1918 (after Parkinson 1950 and AGSO 2000). The inundation area is about 5.5m AHD

The most definite level is in The Harbour and Rivers Engineer's to Parliament which stated that the cyclone was accompanied by an elevation in sea surface in the form of a wave which at Mackay slowly rose for about an hour reaching a **height of 7 foot 9 inches (2.36 metres)** above the highest spring tide level (3.14m at the time) which gives a height of 5.5m. Parkinson (1950) states that sea water rose approximated 8feet above high water level which is in accord with Parliament report. Parkinson included a map (Previous slide) which has been digitised by AGSO (2000) with locations of known deaths marked.

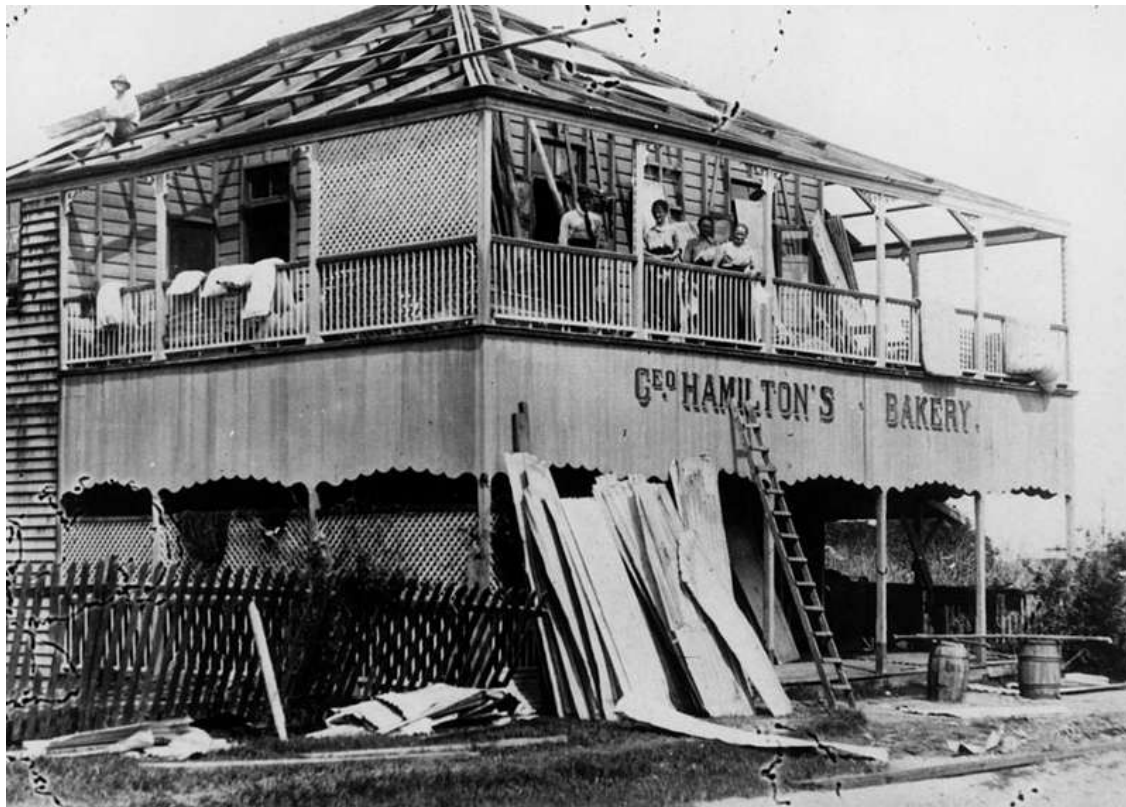
Building damaged in a cyclone in Mackay, 1918 contributed by **QldPics** taken in 1918

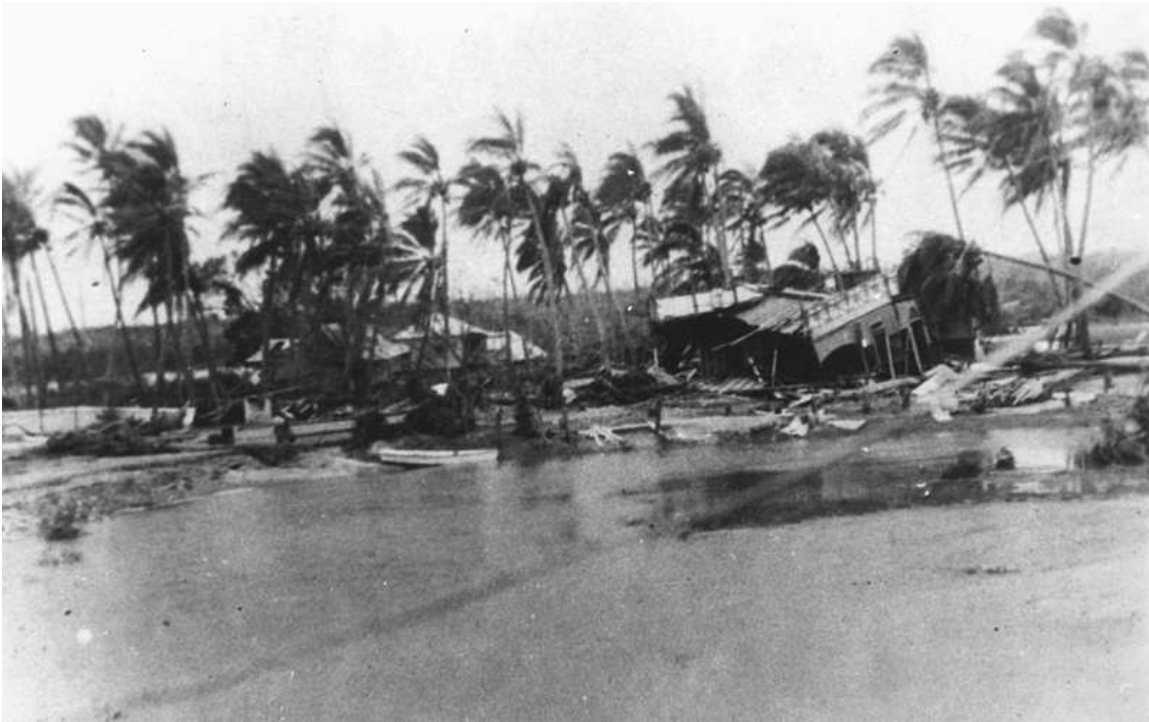
Cyclone damage at the Pioneer River, Mackay, 1918 contributed by QldPics taken in 1918

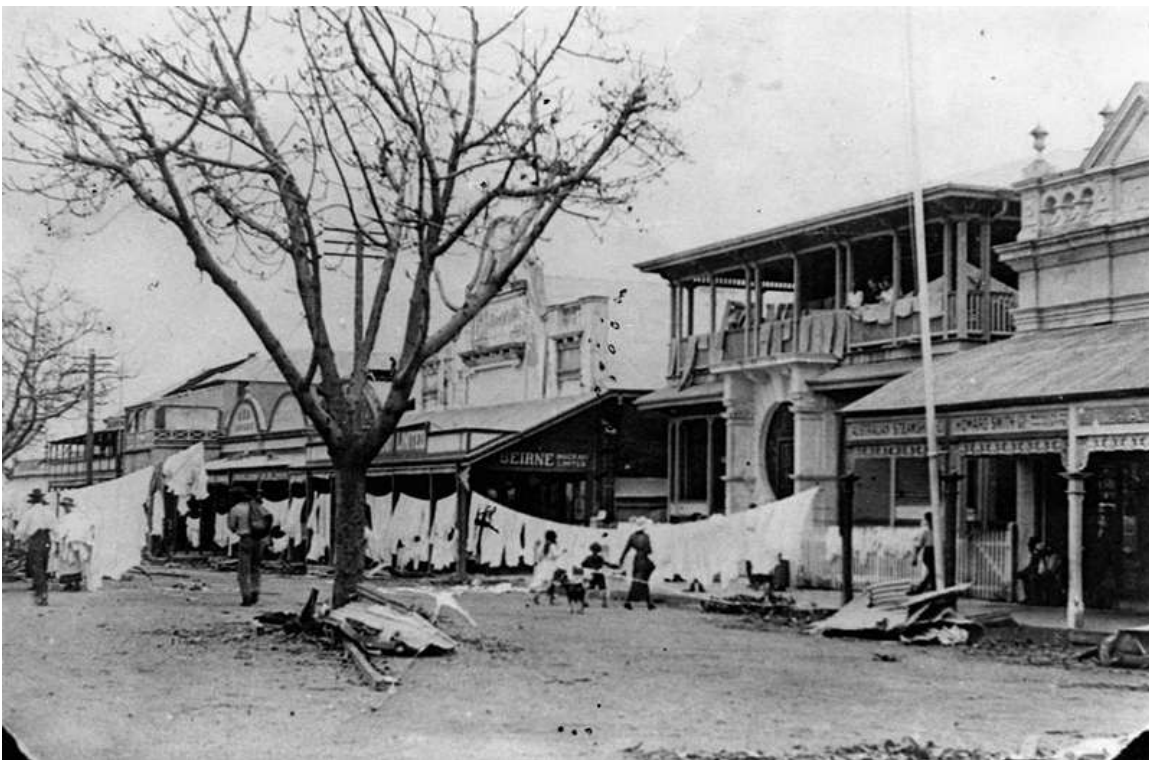
Sydney Street, Mackay, after a cyclone in 1918

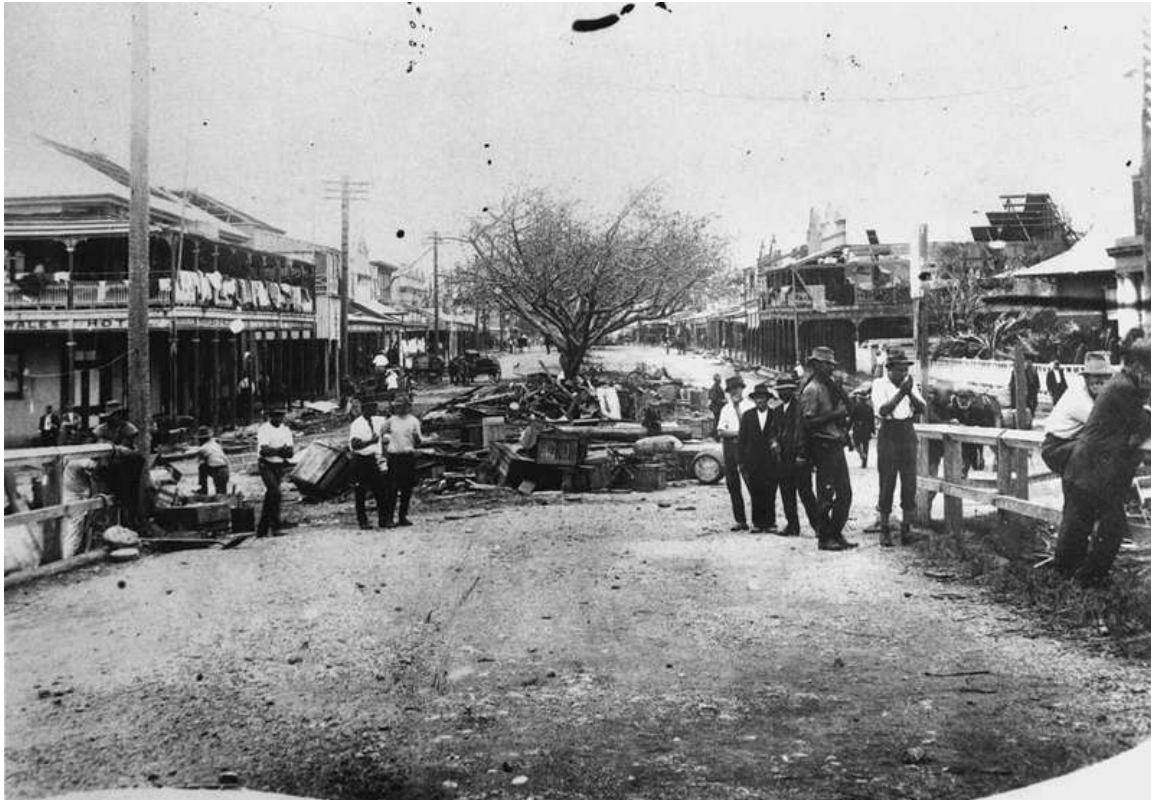
Looking south down Sydney Street after a cyclone in Mackay in 1918. Many unroofed buildings and debris are visible in the street with trees having been stripped of their leaves. Clothing is hanging over the verandah railings to dry.

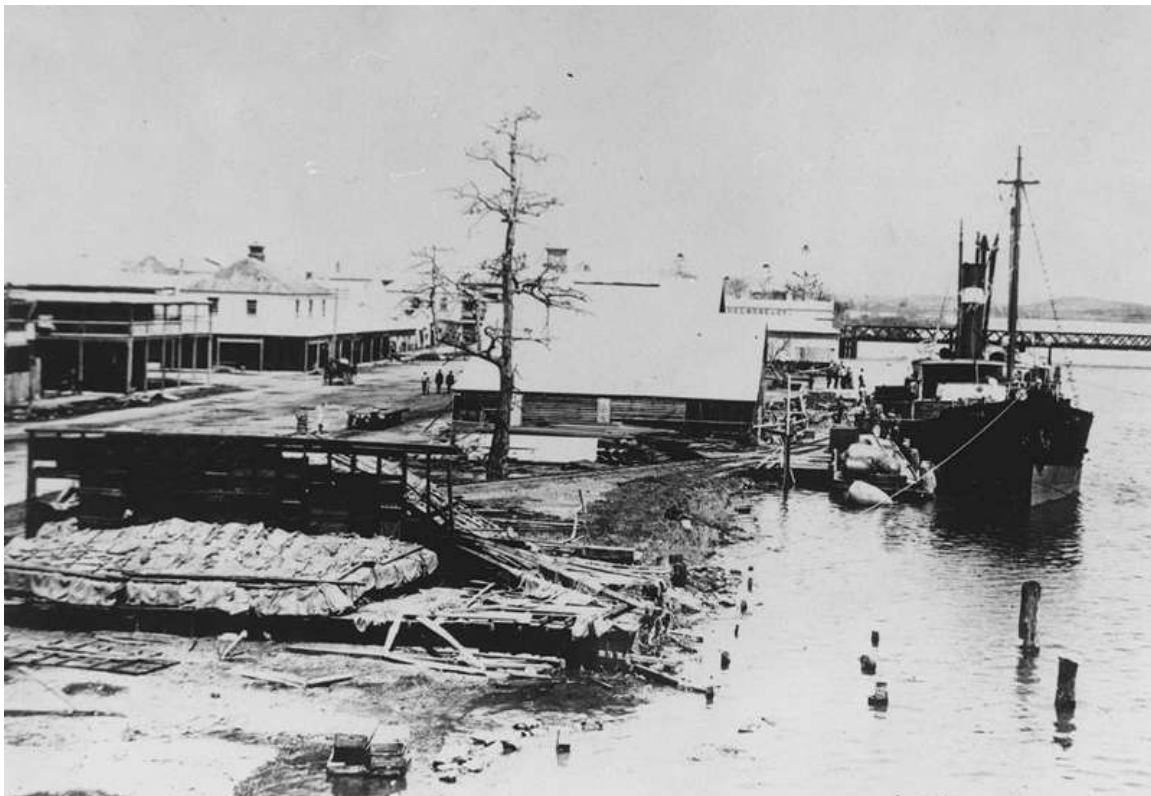
Cyclone damage to Croker's Wharf at Mackay , 1918 contributed by QldPics taken in 1918
