## CASE STUDY: Brisbane Floods, February 1893

By Mr Jeff Callaghan

Retired Senior Severe Weather Forecaster, Bureau of Meteorology, Brisbane

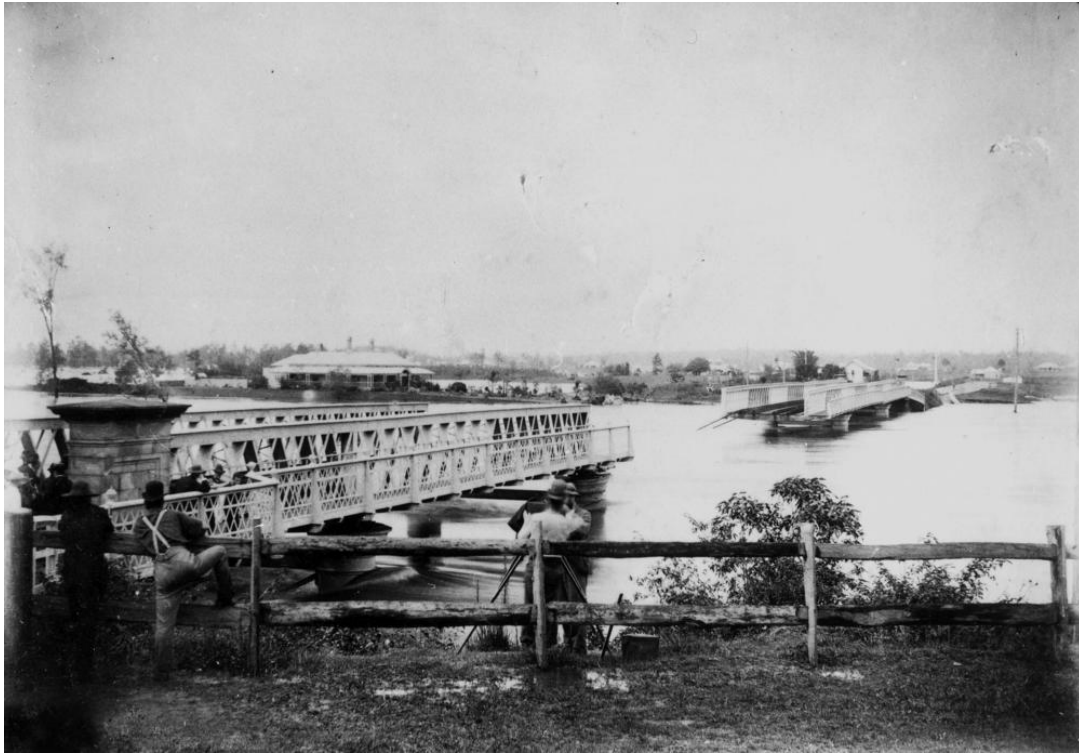
**Figure 2.** Indooroopilly Bridge February 1893 (Public Domain).

The Indooroopilly railway bridge (Figure 2) was washed away by the flood. These were the heaviest floods known in Brisbane and suburbs. The Brisbane City flood peak was 8.35 metres at 7pm 5 February 1893. At Maryborough two men were drowned and a family missing believed drowned while trying to cross the river. Unprecedented flooding at Maryborough with the Mary River Bridge washed away. The river peaked there at 4pm on the 5th with more than 130 families homeless after more than 130 homes were swept away. At Gympie numerous houses were washed away with a large number of homeless. There were other deaths in outlying areas. Four children drowned on the 5<sup>th</sup> and a policeman drowned in a rescue attempt.

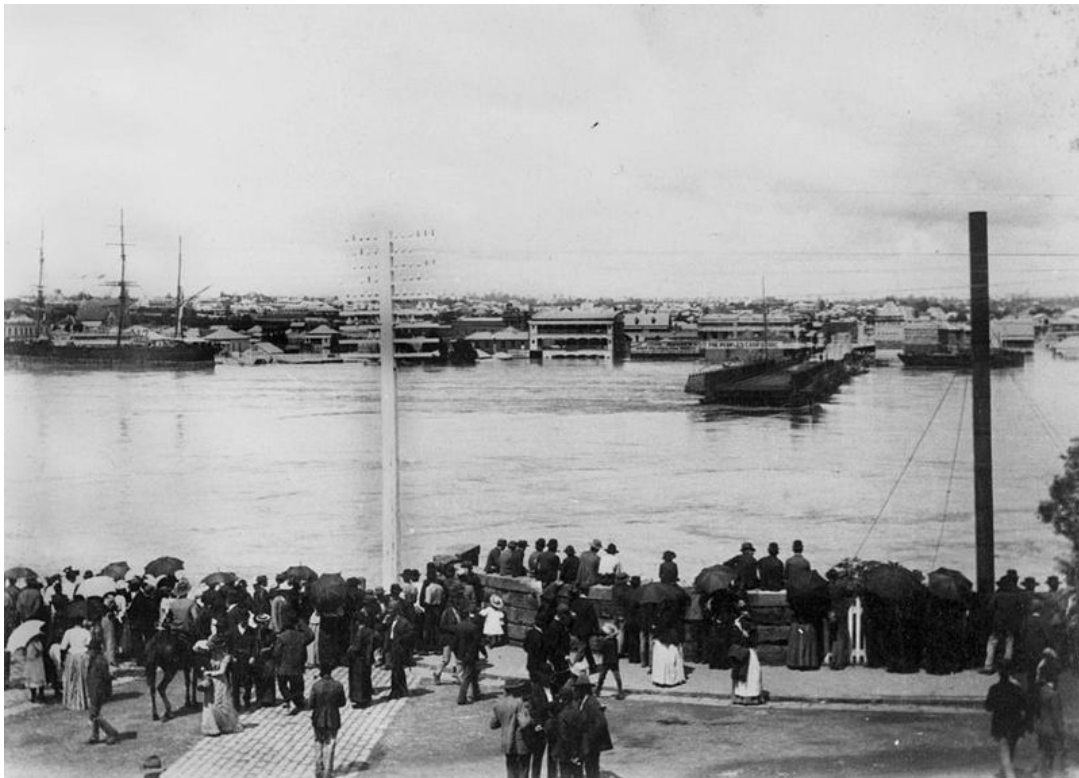
**Figure 3.** Victoria Bridge February 1893 (Public Domain copyright expired)

~~At 12.15pm 6 February 1893~~ **6 February 1893** one third of Victoria Bridge (Figure 3) broke away and other spans of the bridge quickly followed. A man was found drowned at O'Connell Terrace, a boy drowned at Petrie Terrace, a man was drowned at Rosalie and two men were drowned when a punt capsized at West End.
