INVESTIGATION OF TC CHARLOTTE IMPACTS IN THE TOWNSVILLE AREA

Systems Engineering Australia Pty Ltd

TITLE	<i>Investigation of TC Charlotte Impacts in the Townsville Area</i>				
Client	Townsville City Council				
Contract	P/O D/217802	Name	Storm Tide Support		
SEA Job No.	J0813	Document ID:	PR001	Rev:	B
Prepared by:	B A Harper	Approved by:	B A Harper		
Custodian:	B A Harper	Signature:	<i>B A Harper</i> Date: 05/03/2009

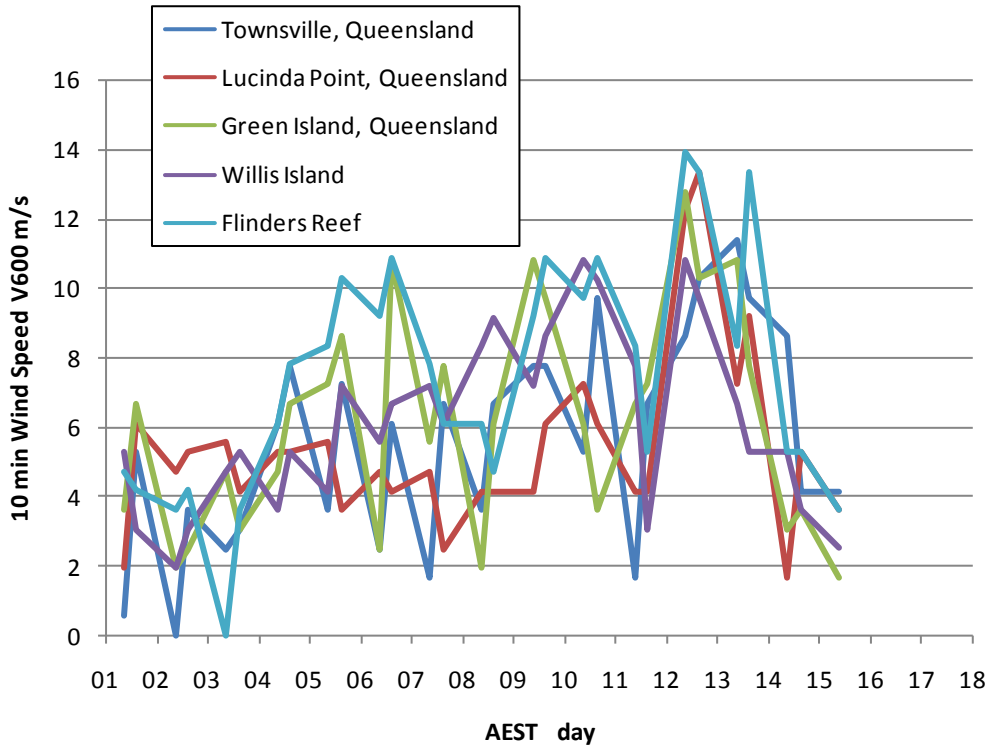
Figure 3 BoM recorded regional wind speeds

Figure 3 summarises 9am and 3pm recorded wind speeds across the region over the preceding fortnight, showing an already active monsoonal development into which the *Charlotte* wind field merged and intensified. The Townsville Airport winds on 12th and 13th are also detailed, showing a strong ESE.

(Top: Evidence of monsoonal development over time; Bottom: Townsville Airport)

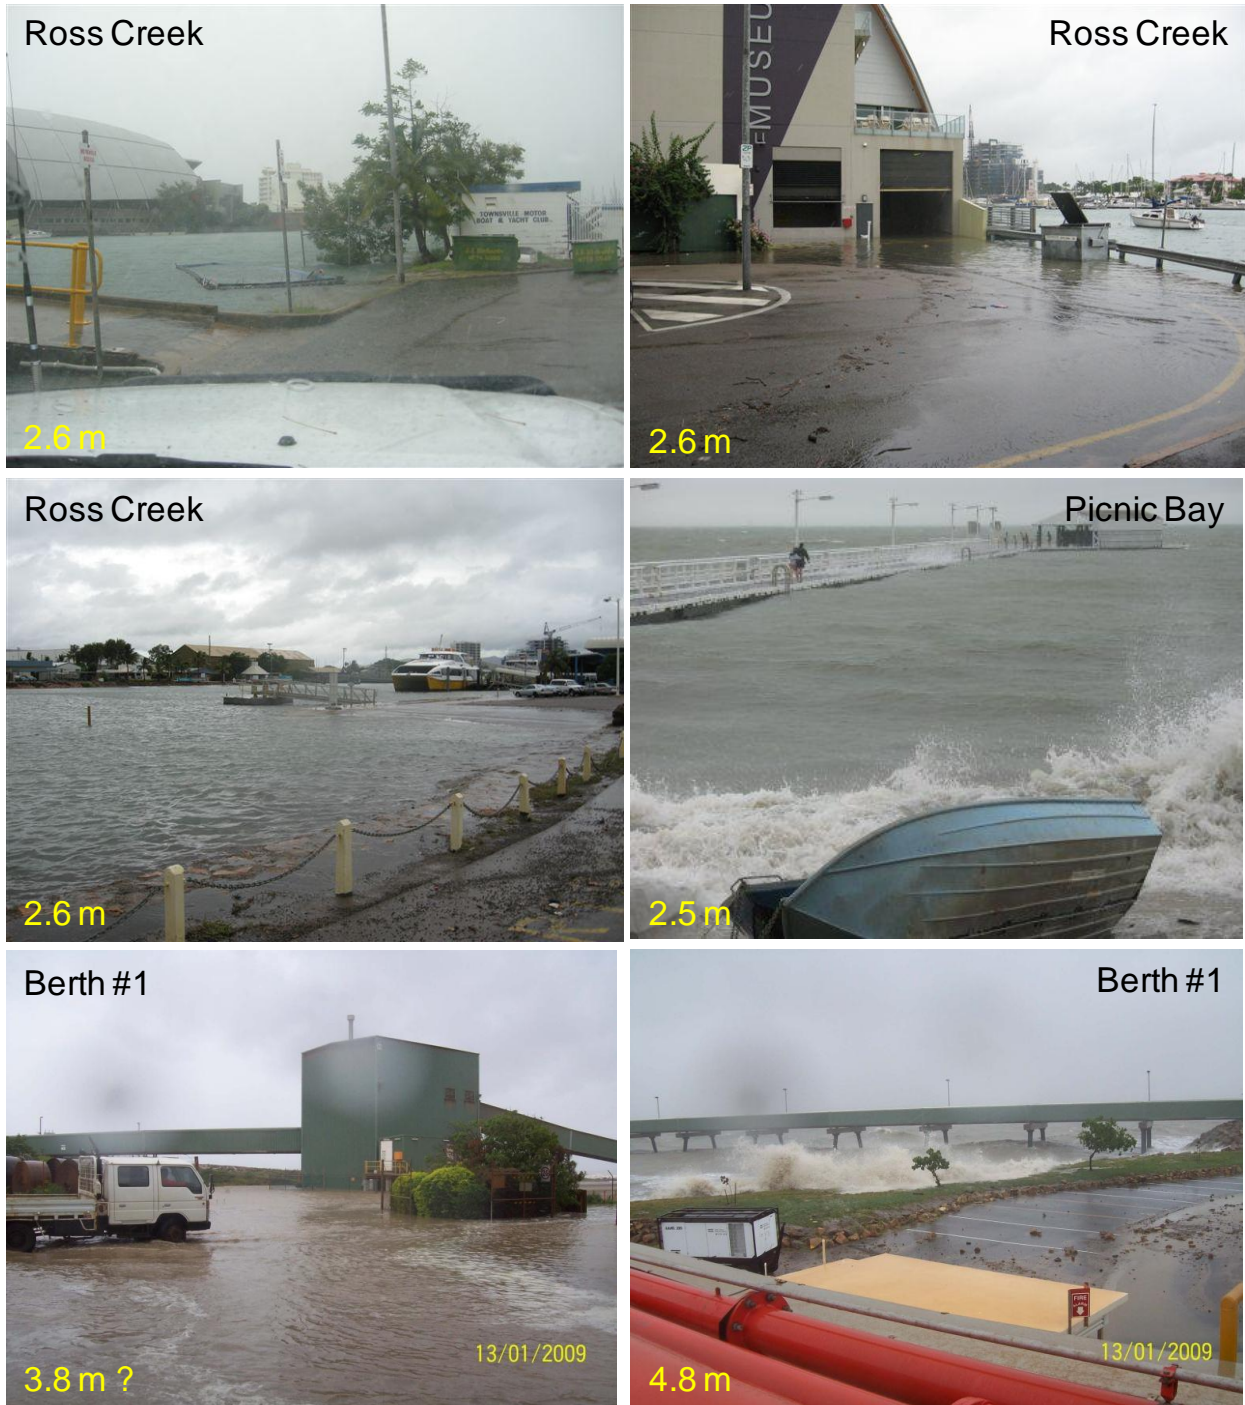
Figure 5 Selected water levels Ross Creek, Harbour and Picnic Bay.

In Figure 5, the Ross Creek levels are consistent with the nearby tide gauge maximum (refer Figure 10 also). The Picnic Bay level is slightly lower but consistent with the expected slight tidal attenuation relative to the Harbour. The Harbour levels are considerably higher and the ponding evident may be due to poor drainage in that vicinity or perhaps some wave setup affecting the drain tailwater. The debris line at the car park is amongst the highest levels found in the region, indicating added wave setup and runup at the exposed rubble-mound revetment.

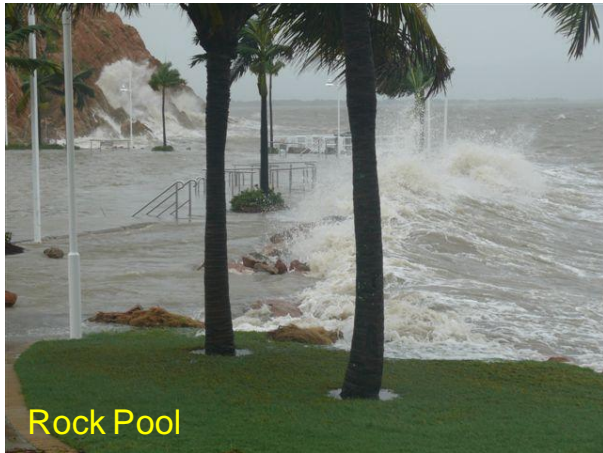
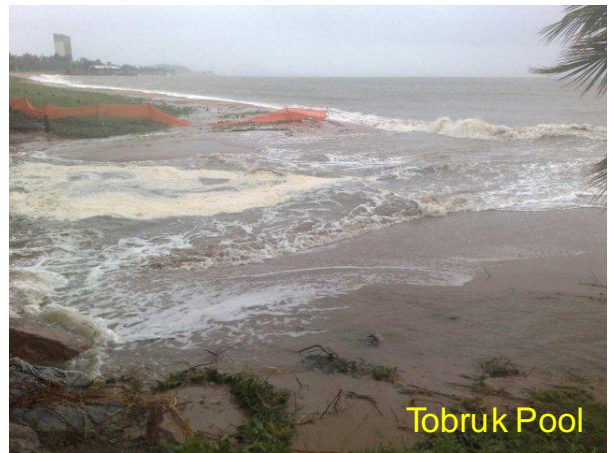
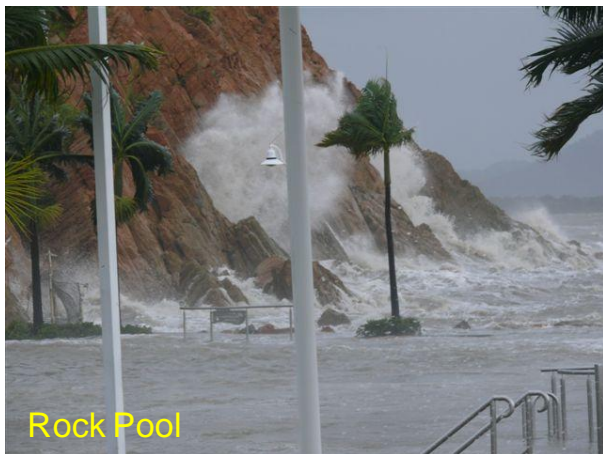
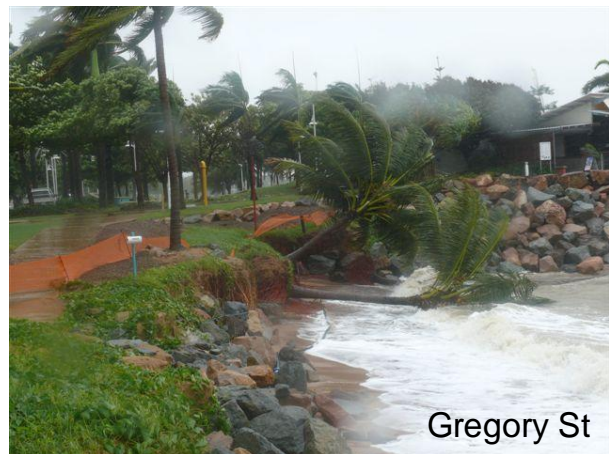
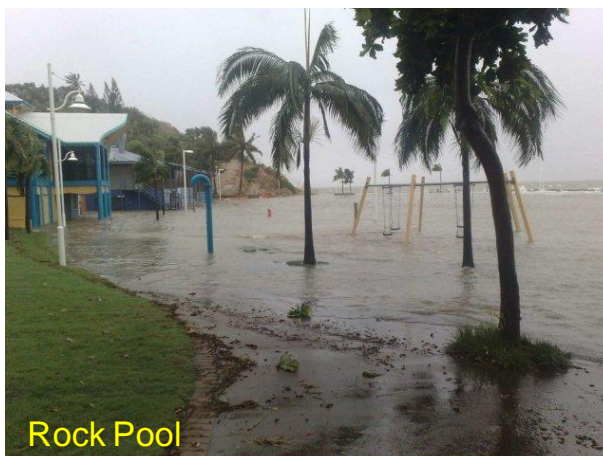
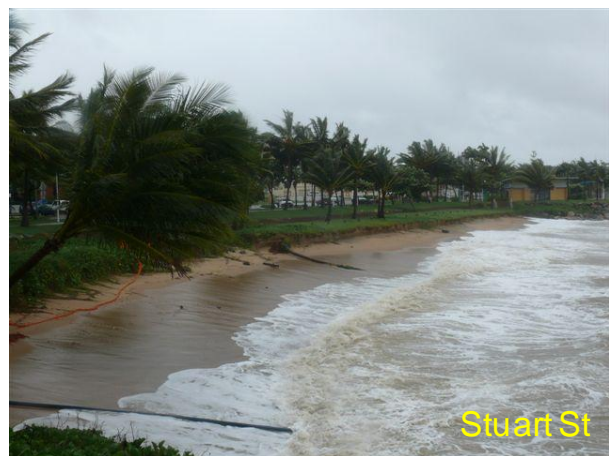
Figure 6 Selected beach impacts along The Strand.

In Figure 6, wave effects on top of the elevated levels eroded portions of the beaches, mainly on the southern side of the revetment headlands. At the Rock Pool, wave setup and runup was significant and dislodged some armour stone, depositing it in the enclosure. The ground levels of the life saving club and restaurants were inundated and appear to have been the highest stillwater levels in the area.

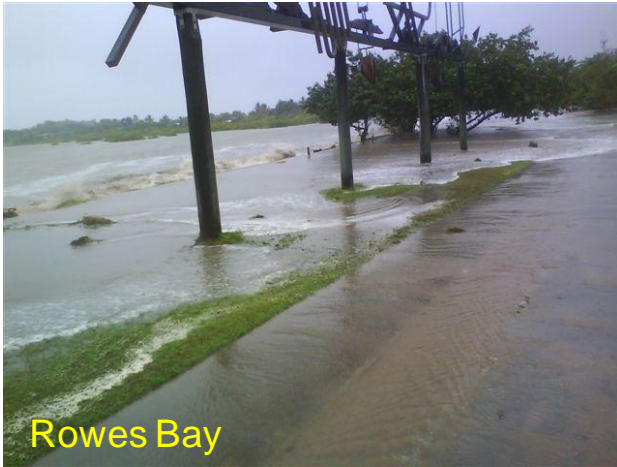
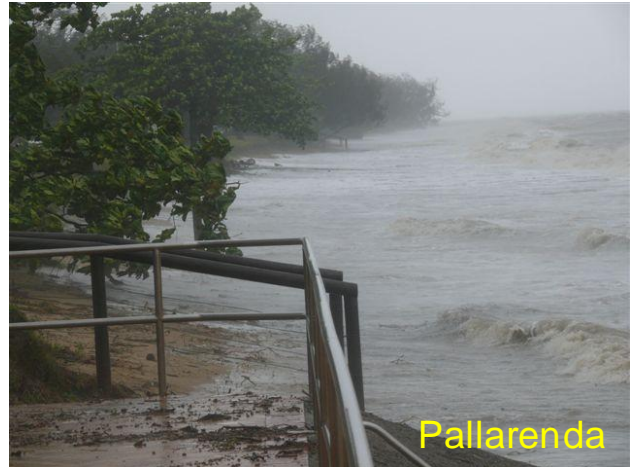
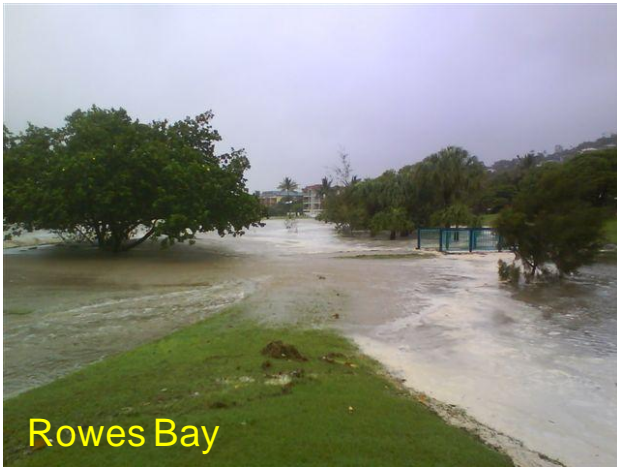
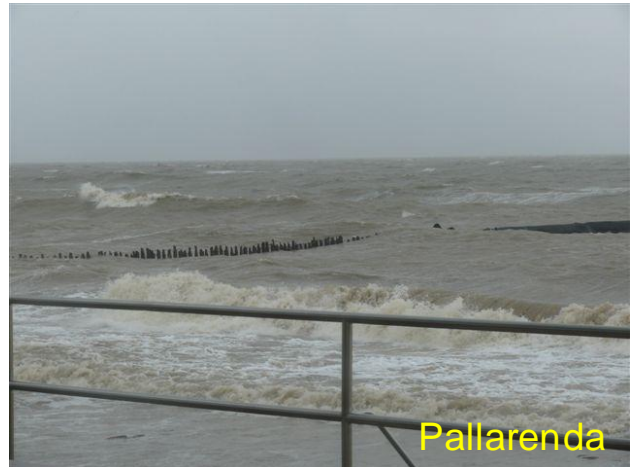
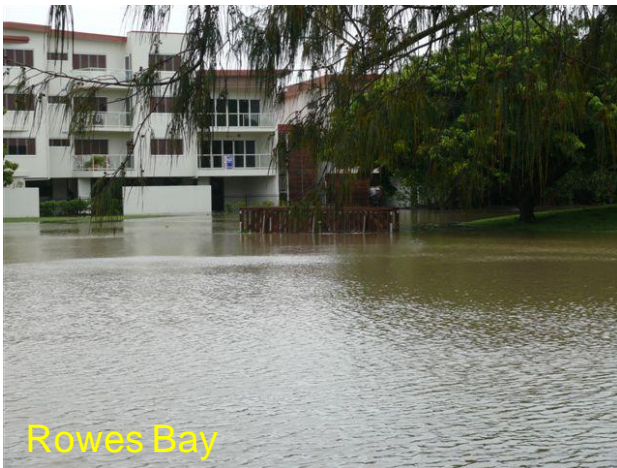
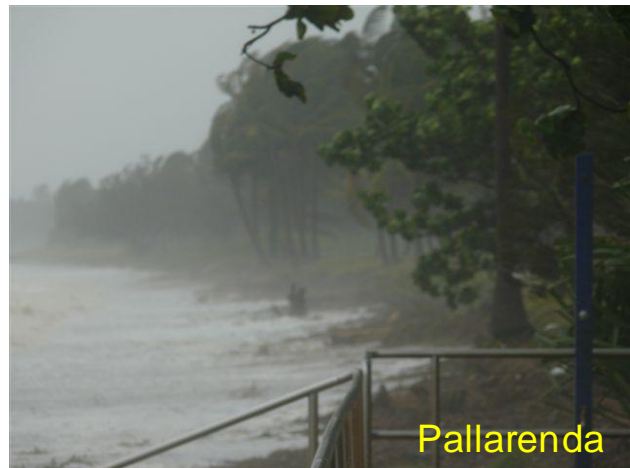
Figure 7 Selected beach impacts Rows Bay and Pallarenda.

In Figure 7, properties near Rowes Bay / Belgian Gardens were affected and Soroptimist Park was overtopped. The Pallarenda foreshore was also impacted (these photos apparently taken on 14/01).

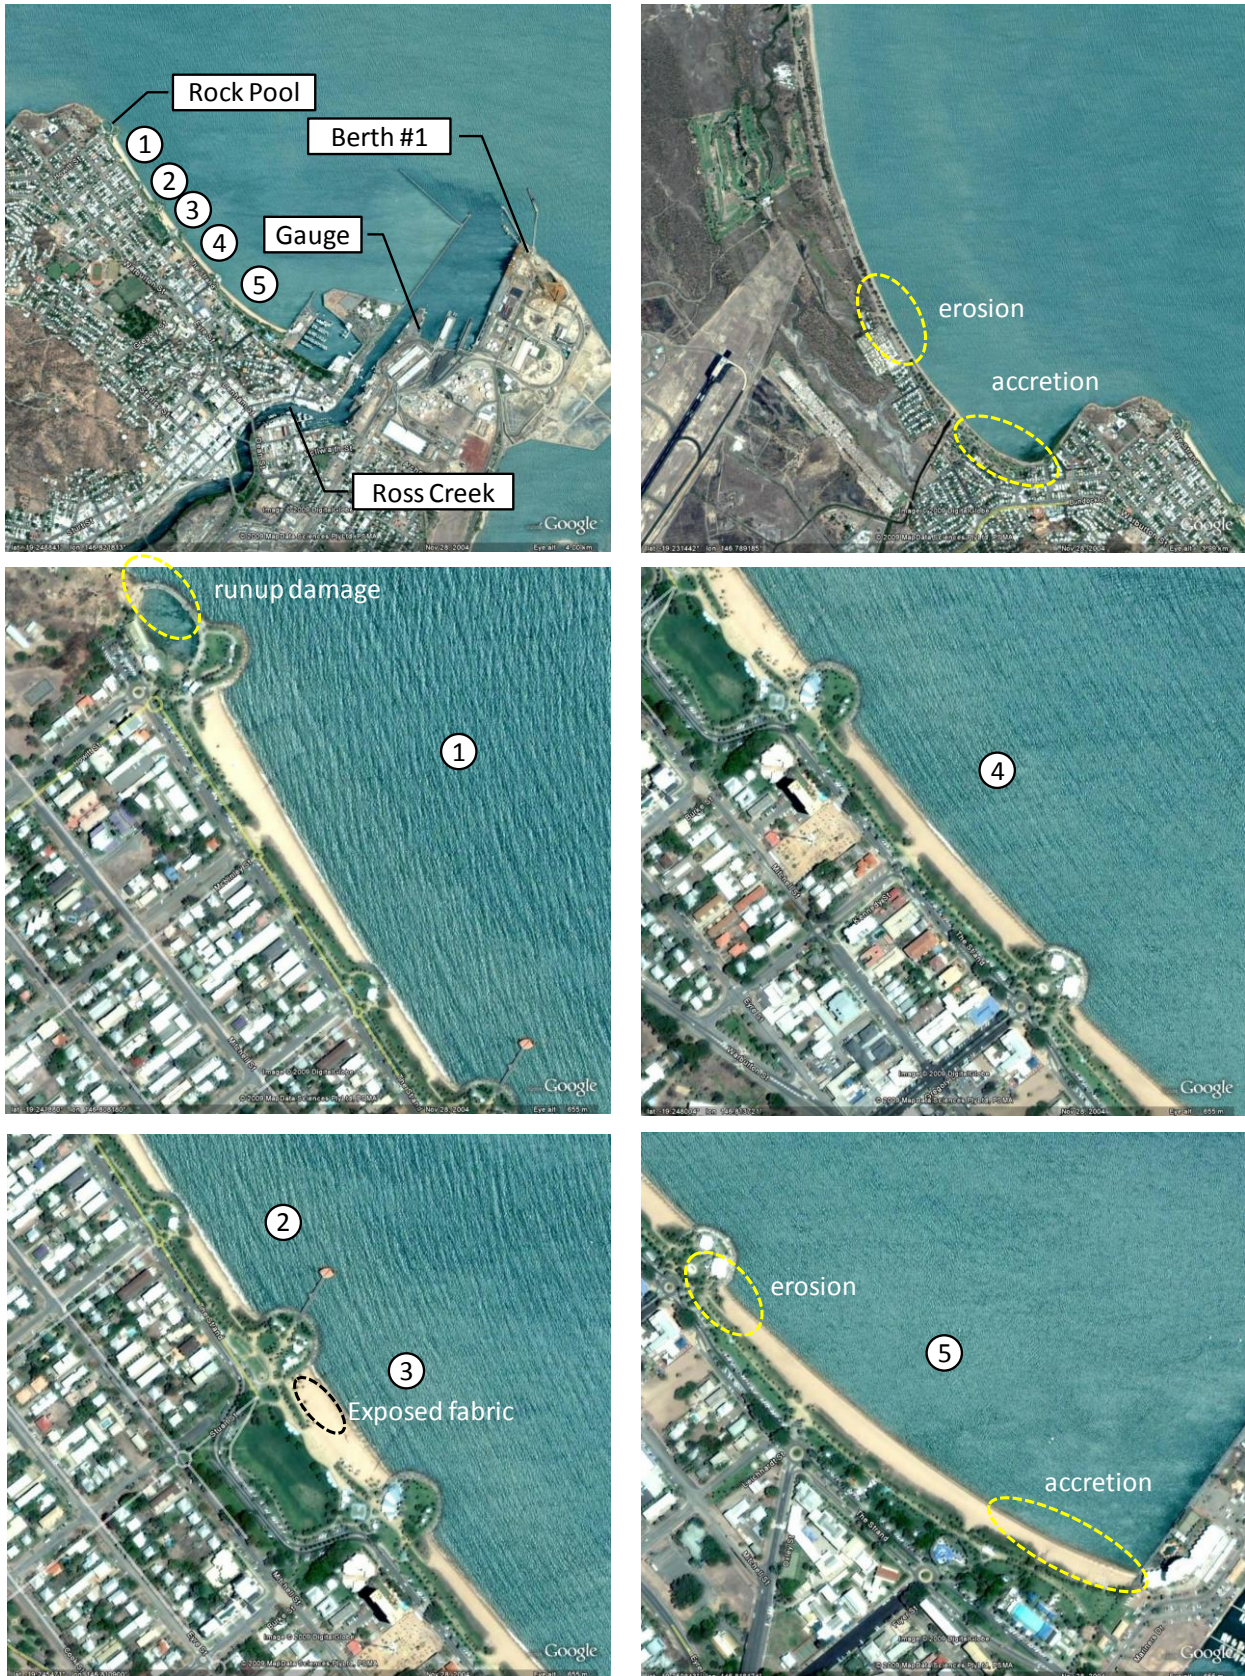
Figure 10 Surveyed areas of The Strand and Rows Bay.

Examples of the site inspection and survey work are given in Figure 10 through Figure 12. Figure 10 provides a key diagram for The Strand beaches and indicates typical areas suffering erosion (normally northern corners) or accretion (normally southern corners), consistent with the angle of wave attack. Effects along beaches 1 through 4 were similar, with evidence of lee sheltering from the harbour breakwater at the southern end of beach 5. Erosion occurred at the abutment of each headland revetment as a result of concentrated wave energy and was often greatest on the more exposed southern sides. All floating swimming enclosures appeared undamaged, albeit clogged by seagrass flotsam and sand. The Kissing Point rock pool suffered superficial damage and scour.

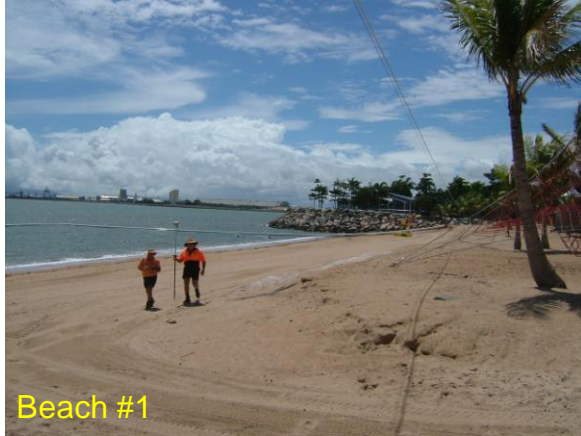
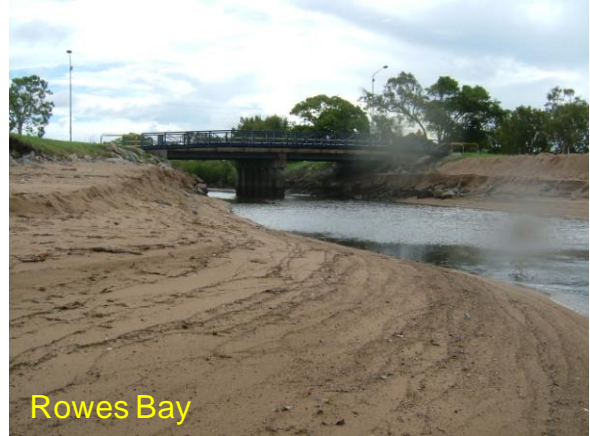
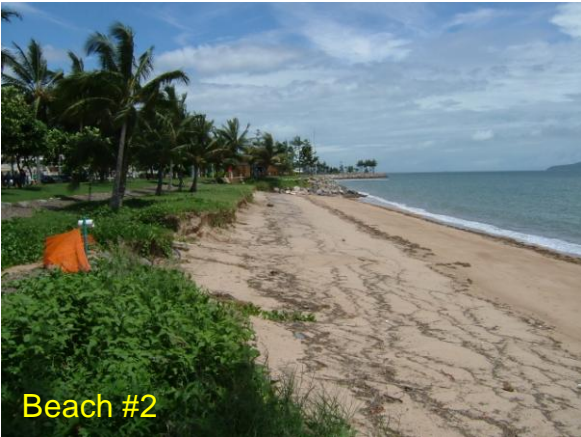
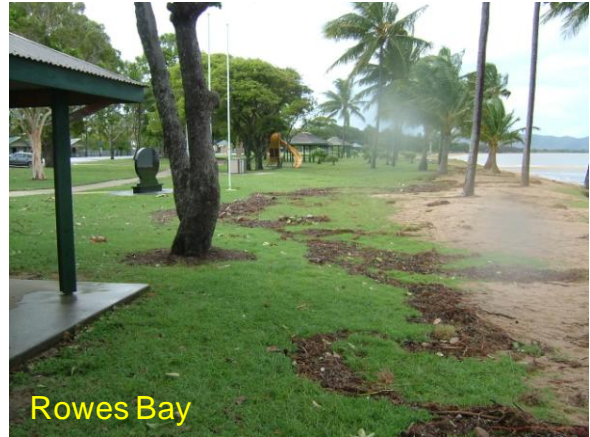
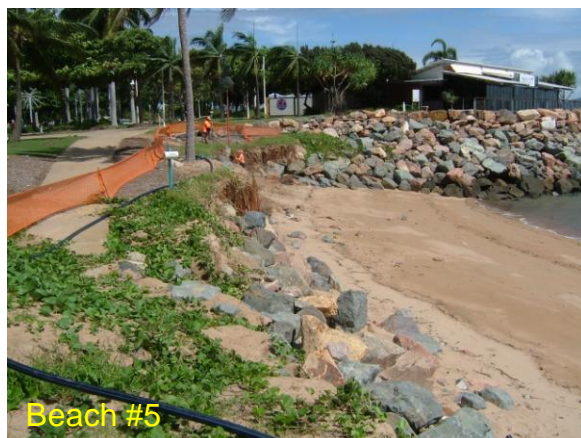
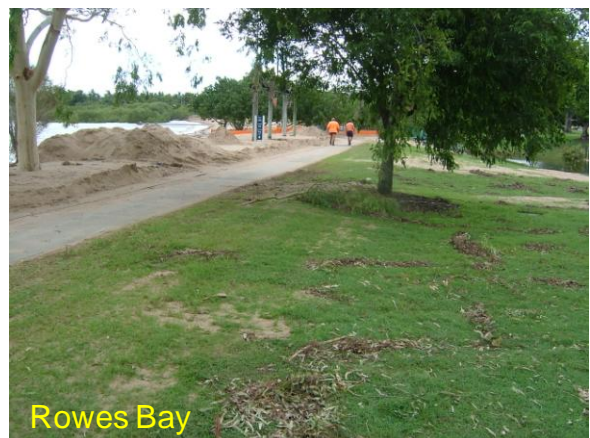
Figure 11 Site inspections The Strand and Rowes Bay.

Figure 11 shows photographs taken on the 16th during the site survey and inspection of The Strand and Rowes Bay areas. Only the southern portion of Beach #5 (near Tobruk Baths) experienced accretion, with the forebeach being loaded with about 0.3 m of sand over a distance of 50 to 100 m. The northern end near Gregory St headland suffered bank erosion adjacent to the revetment abutment with the loss of several established palm trees. At Rowes Bay the southern corner near Soroptimist Park was accreted with up to 0.5 m of sand deposited over some areas. The nearby entrance to the Lynam St drainage canal was heavily eroded, possibly also due to streamflow, and a beachside carpark to the north was destroyed. Beach access infrastructure between Rowes Bay and Pallarenda was mostly destroyed.

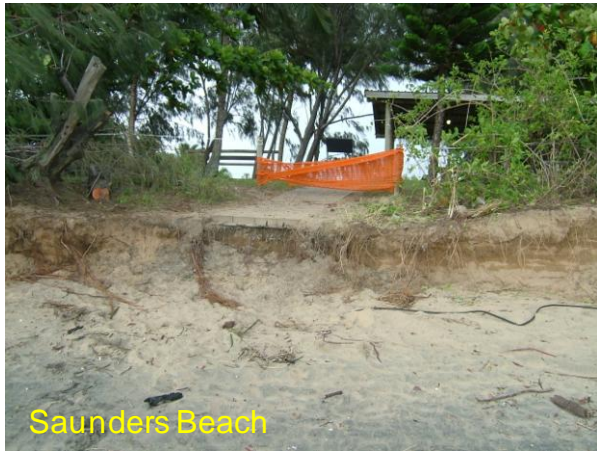
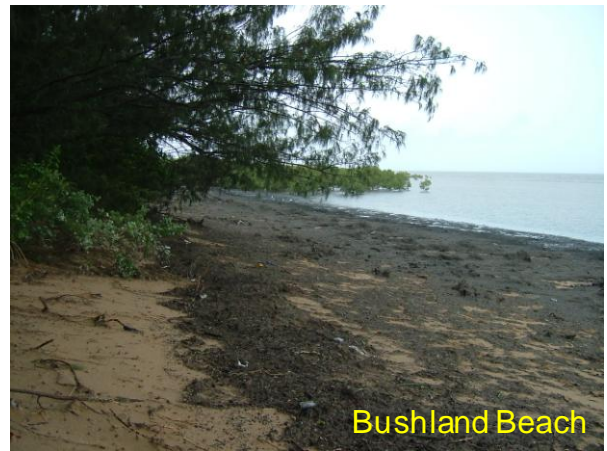
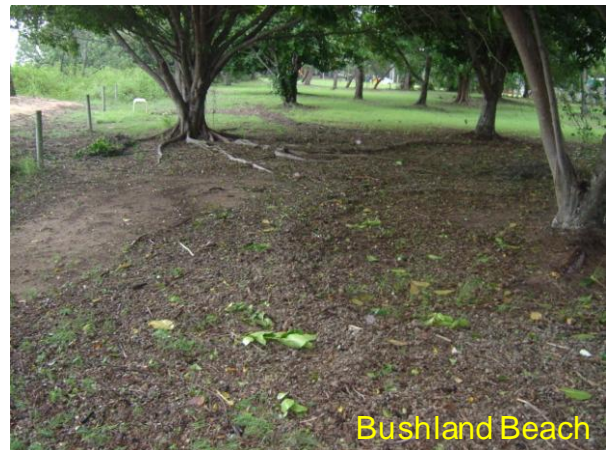
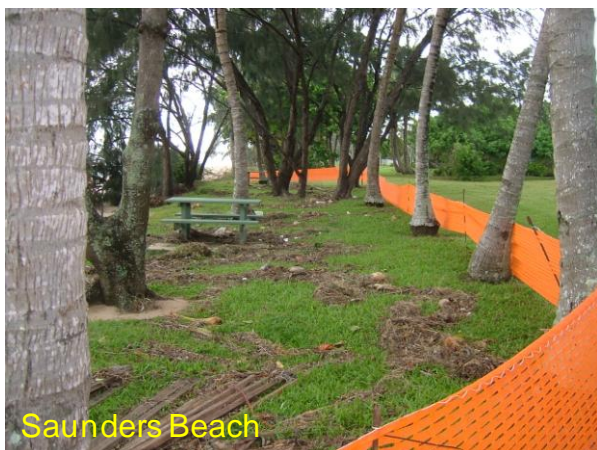
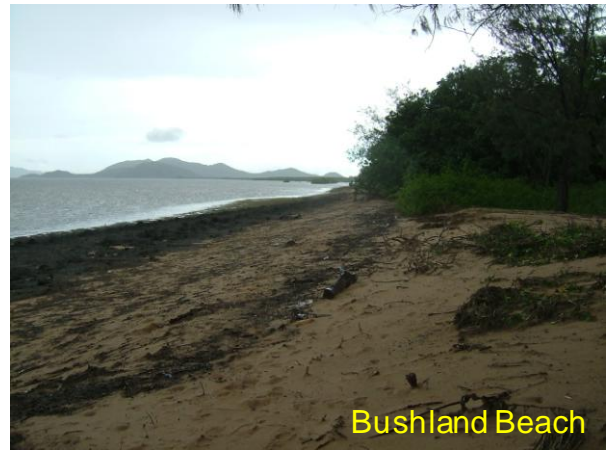
Figure 12 Site inspections Saunders Beach and Bushland Beach.

Figure 12 summarises the author’s findings at Saunders Beach and Bushland Beach. At Saunders Beach there was evidence of dune overtopping at some locations and a beach erosion scarp was evident that damaged beach access infrastructure. At Bushland Beach, which is very flat, no scarp was evident but large deposits of seagrass covered the beach and debris lines encroached onto the nearshore parklands within 50 m of some residences. The inspection at Bushland Beach was limited to the area near the hotel/motel at the beach end of Mount Low Parkway.

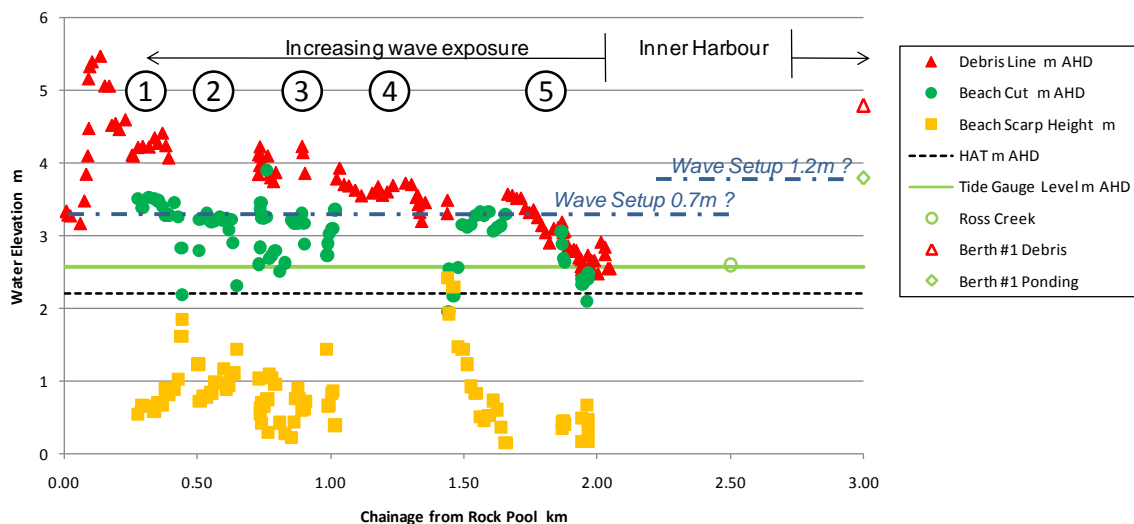
Figure 13 Analysis of The Strand survey data.

The results of the water level and erosion survey for The Strand have been summarised in Figure 13. The red triangles show the surveyed debris lines generated mainly by wave runup, which are highest at the northern end of Beach #1 immediately next to the Rock Pool. Moving south along the beaches, the debris line rises and falls slightly depending on the northern or southern side of each headland but steadily decreases to the protected Tobruk Pool end of Beach #5. The green dots trace the height of the toe of the beach scarp and the yellow squares indicate the absolute height of the scarp, which was highest at the southern side of the Gregory St headland. The solid green line shows the tide gauge peak level of 2.57 m AHD, which correlates well with the photographic evidence in Ross Creek. The Outer Harbour site ponding and debris levels are then shown

It is possible to infer wave setup contributions based on these levels. Firstly, the Rock Pool stillwater debris level itself is likely a reasonable estimate of the wave setup immediately

offshore. Secondly, the toe of the beach scarp might also be considered an order of magnitude estimator of wave setup. In this case, the higher scarp toe and the Rock Pool levels are similar, suggesting a wave setup component of the order of 0.7 m at its highest. Similarly, taking the Berth #1 ponding level as perhaps indicative, a setup of about 1.2 m is possible at this more exposed location.

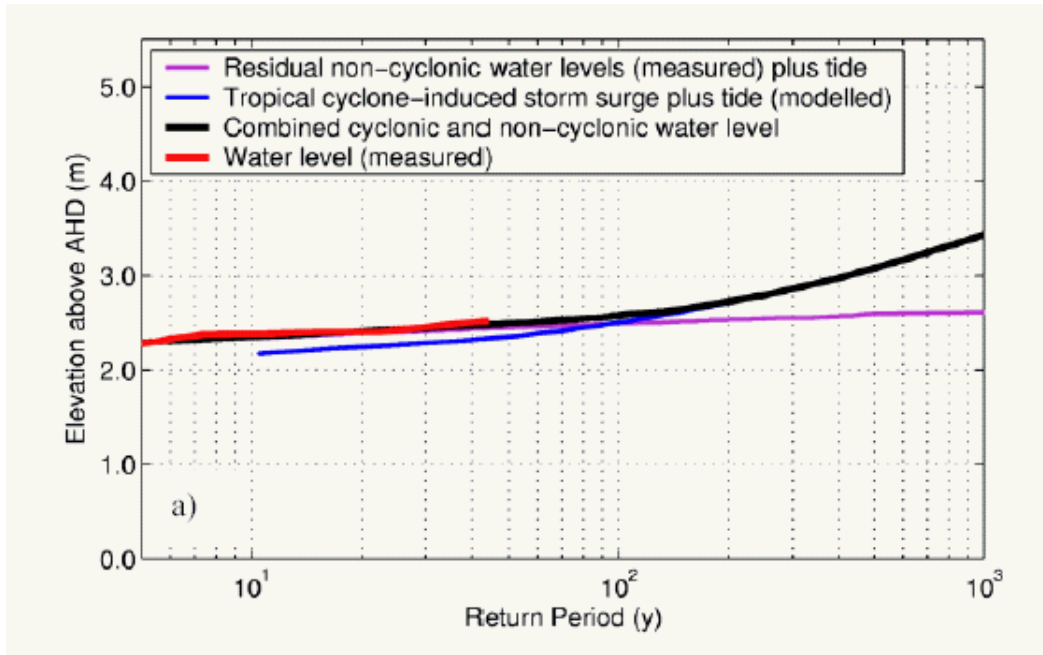
Figure 14 Cyclonic and non-cyclonic analysis for Townsville from Hardy et al. (2004)

However, in the Queensland Climate Change Study (Hardy et al. 2004), some consideration was given to these types of events and a specific case study was included for Townsville as an example. An analysis was undertaken of the residual water levels from the Townsville tide gauge over a 44 year period, specifically excluding times when tropical cyclones were known to have been active in the area. While this would also tend to exclude events like TC *Charlotte*, it remains somewhat representative of this type of phenomenon. The resulting water levels then represented situations when “other” types of weather events had influenced the total water level. This was then sampled in a statistical model and randomly combined many hundreds of times with real tide records for a period of 250 years. In this way a “non-cyclonic” tide plus surge water level return period curve was obtained, which extended from slightly above HAT to merge with the “cyclonic” return period line at about the 200 year return period. The “cyclonic” and “non-cyclonic” probability curves were then appropriately merged, as shown in Figure 14 (part of §Fig 16 from Hardy et al. 2004). No wave setup analyses are available for this situation.

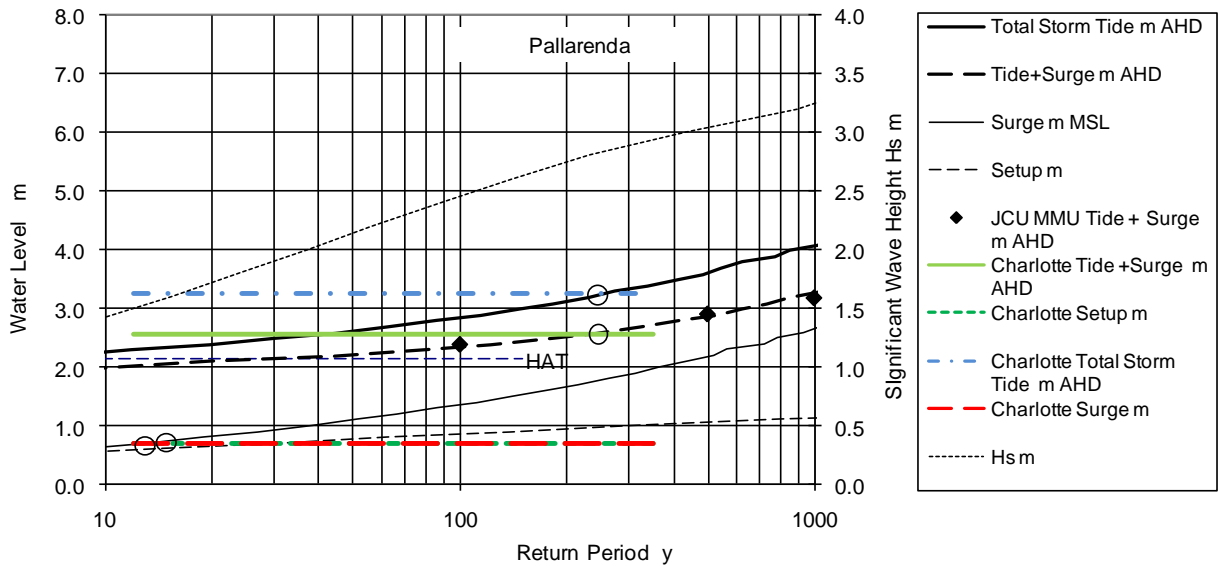
Figure 15 Comparison with cyclonic-only analysis for Townsville from GHD (2007)

In any case, the data for *Charlotte* can be usefully compared with the results from the GHD study, as shown in Figure 15 for Pallarenda as an example. This shows the GHD/SEA predicted “cyclonic only” levels and also the Hardy et al. (2004) “cyclonic only” results for this location, which are quite similar. Overplotted on this are the various water levels for *Charlotte* obtained from this investigation and the approximate intersection with “cyclonic” return periods (open black circles). This shows that the *Charlotte* wave setup and storm surge are relatively low return period events in a “cyclonic” situation, but the tide + surge and total water levels are relatively rare even for “cyclonic” conditions, being in excess of a 200 year average Return Period.

By allowing for the slight raising of the return period curves as per the Hardy et al. (2004) analyses for “combined non-cyclonic and cyclonic”, this indicates a total water level probability of about one in 200 years for this unusual *Charlotte* “pseudo-cyclonic” event.
