HARDEN UP

CASE STUDY: Brisbane Tornado, 4th November 1973

By Mr Jeff Callaghan

Retired Senior Severe Weather Forecaster, Bureau of Meteorology, Brisbane

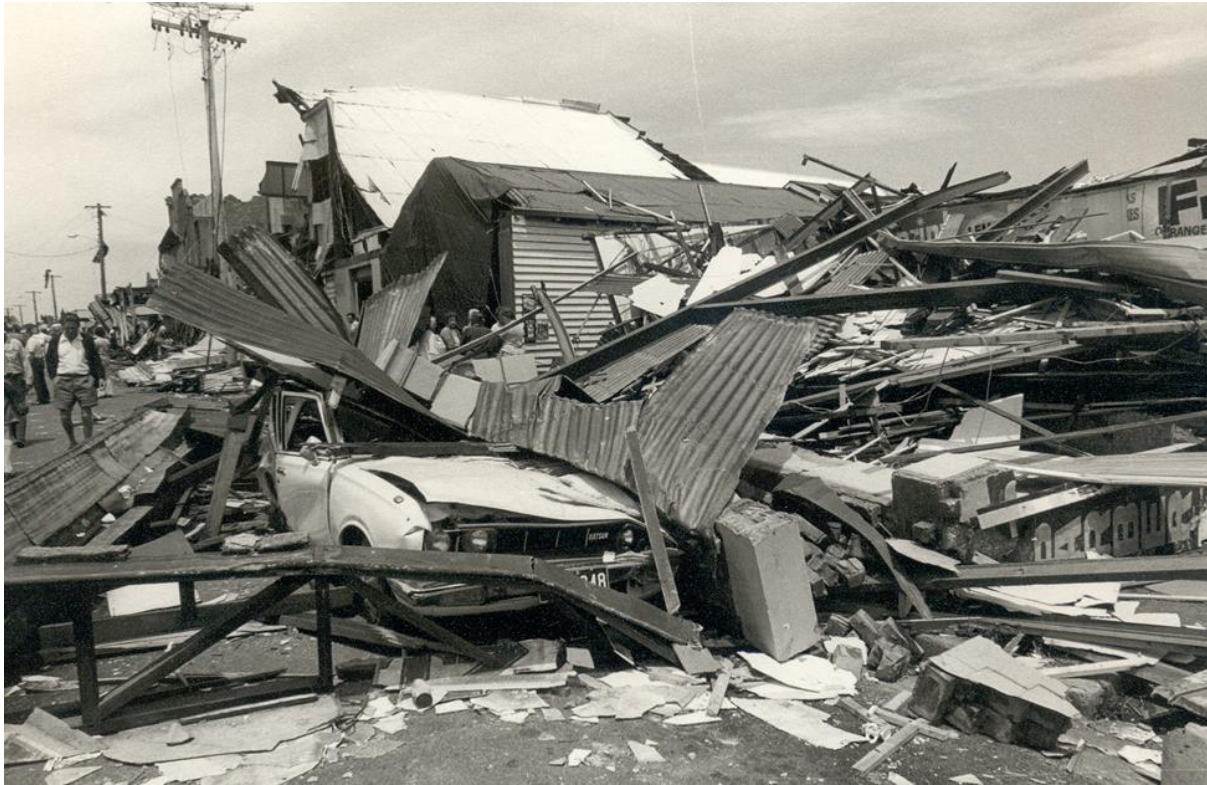
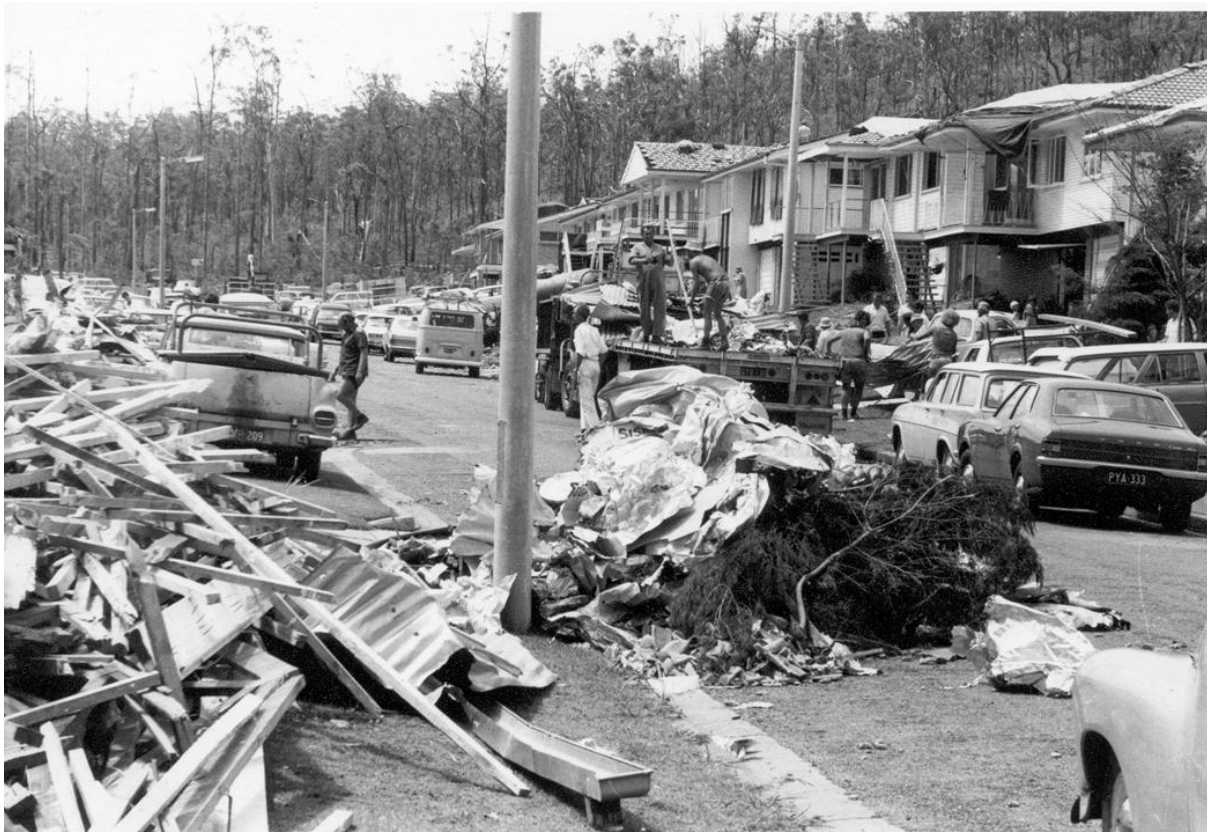
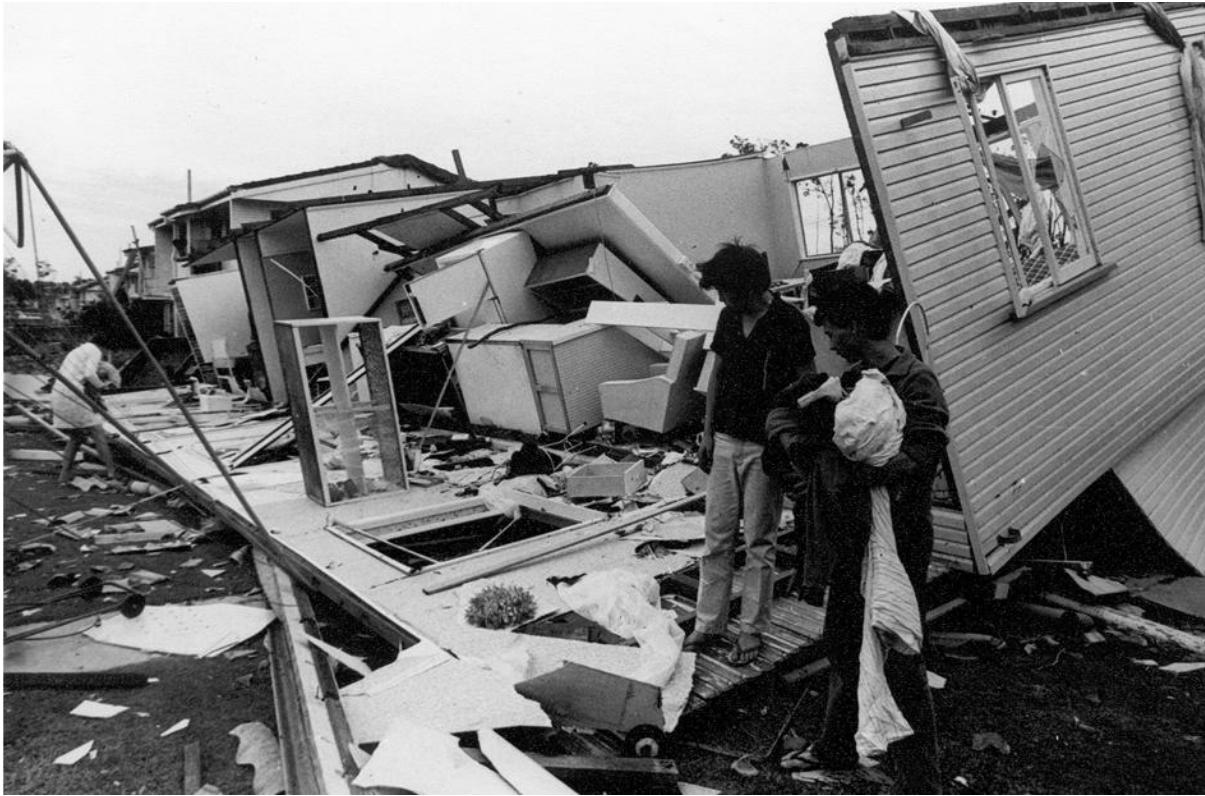
Damage Photos

This was perhaps Australia's most damaging tornado. It had an extremely long track travelling from Brookfield to 8 Mile Plains and then across to Victoria Point (see Figure 1). The length of the track was 51 km and 100 m to 230 m wide. It caused severe damage with 500 houses unroofed, 1390 damaged and 500 declared structurally unsafe.

At the end of this report are three damage photos showing the destruction.
