## CASE STUDY: The Innisfail Cyclone, 1918

By Mr Jeff Callaghan

Retired Senior Severe Weather Forecaster, Bureau of Meteorology, Brisbane

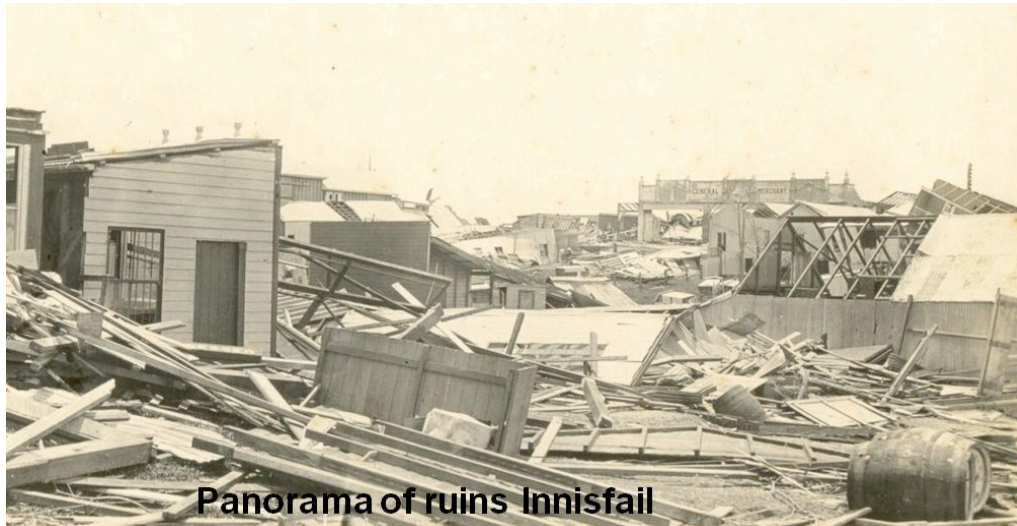
**Panorama of ruins Innisfail**

**Figure 4** Damage photographs Innisfail March 1918

Below the devastation at Innisfail is shown from photographs taken soon after the event.

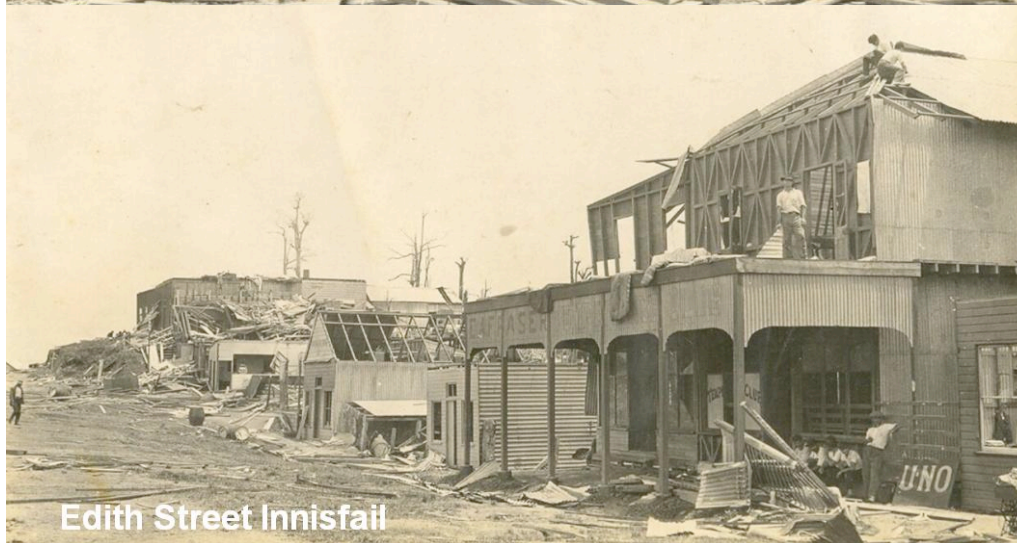
**Edith Street Innisfail**

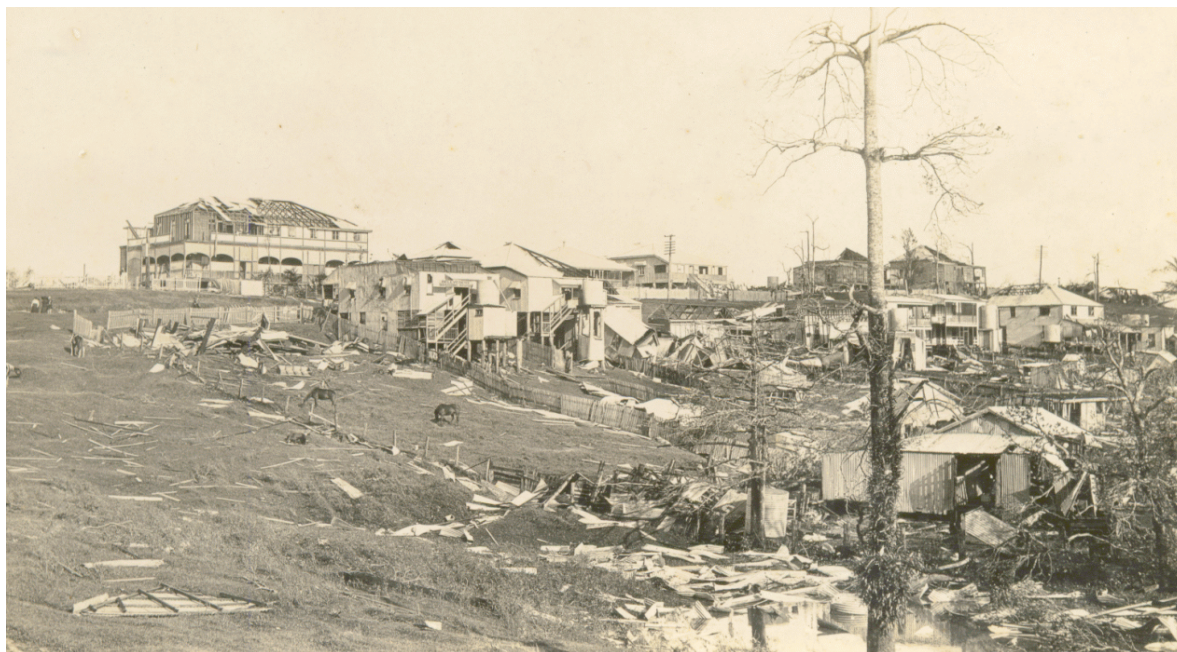
**Figure 5** Roman Catholic Convent and Environs Innisfail 1918
