CASE STUDY: Mackay Cyclone, 1918

By Mr Jeff Callaghan

Retired Senior Severe Weather Forecaster, Bureau of Meteorology, Brisbane

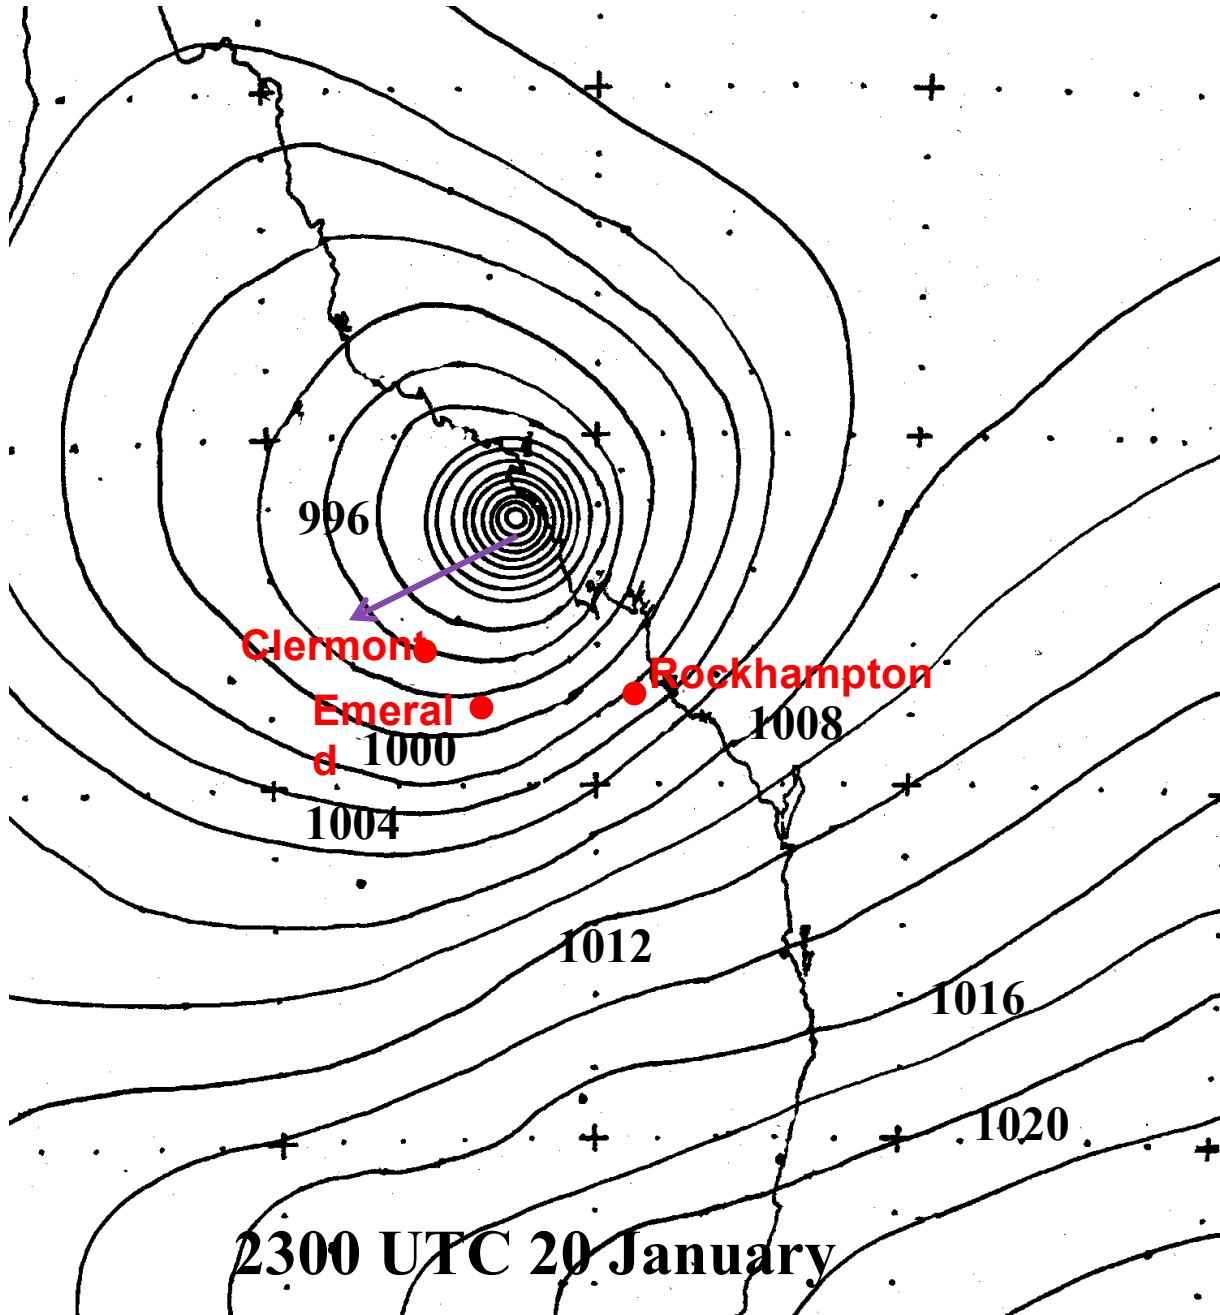
From Harper 2001, an analytical model of the wind and pressure fields of the cyclone was created using a modified form of the Holland (1980) model (Figure 1).

Input data to the model included the Croker pressure observations, a report of an half an hour calm at Eimeo, other pressure observations in the Mackay area and further out in the environment of the storm. Two parameters, the radius of maximum winds and a value defining the change in wind speed near this radius were varied by trial and error so that the available data was replicated by the model. The result is in Figure 1 together with the track which best fitted the data.

Mean sea level analysis at 9am 21 January 1918 with its subsequent track over the next 24 hours indicated by the blue arrow.
